Service Bulletin

Machinery Affected:	RoofTracker™ and AutoPress 14TL™ Presses
Document:	SB194
Title:	Replacing Light Bar Receiver
Applies To:	Omron ST/™ Light Bar PA4600
Distribution:	Customers, All With PA4600 Light Bars in Date Range

Item # and Rev.	SB194
Date Created	19 August 2011
Created By	R. Tucker
Reviewed by	M. Kanjee
Approved by	G. Pritchett
Applicability	Omron Light Bars
Applicability	Omron Light Bars series PA 4600
Applicability	U U
Applicability	series PA 4600
Applicability	series PA 4600 manufactured

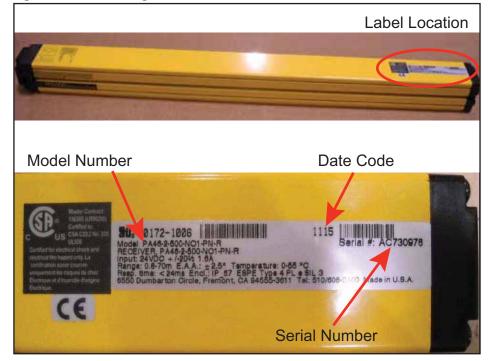
Figure 1: Determining Your Model Number

The light bars affected were manufactured between 1 January 2008 and 31 December 2009 with the model numbers listed in Table 1.

If your model number and date code is within those listed below, continue reading this Service Bulletin. If not, no further action is required.

* The first 2 digits of the Date Code represents the year of manufacture. The last 2 digits of the Date Code represents the week.
