## PAD TOP CHORD TO MATCH ROOF PLANE

MII-REP11A

MiTek USA. Inc.

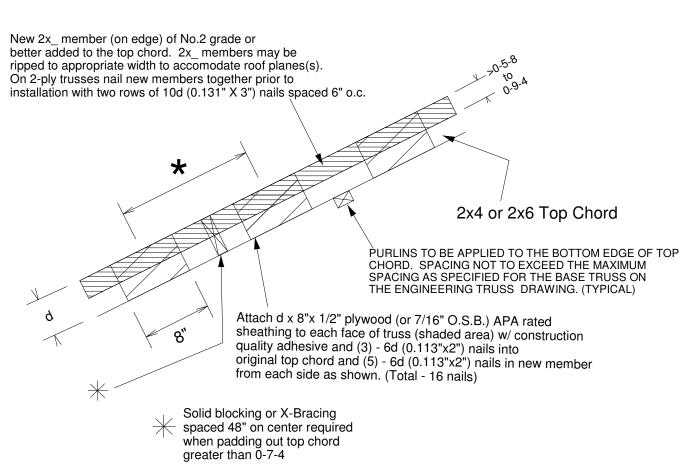
This repair to be used only with trusses (spans less than 40') spaced 24" o.c. maximum and having pitches between 3/12 and 12/12 and total top chord loads less than 50 psf.

Trusses not fitting these criteria should be examined individually.

4. WHEN NAILING THE PLYWOOD GUSSETS AND/OR SCABS, THE USE OF A BACKUP WEIGHT IS RECOMMENDED TO AVOID LOOSENING OF THE CONNECTOR PLATES AT THE JOINTS OR SPLICES.

Maximum gusset spacing to be the lesser of 36" o.c. or the maximum Top Chord purlin spacing as shown on the individual Engineering Truss Drawings.
