## TOP FIVE HANGER INSTALLATION ERRORS

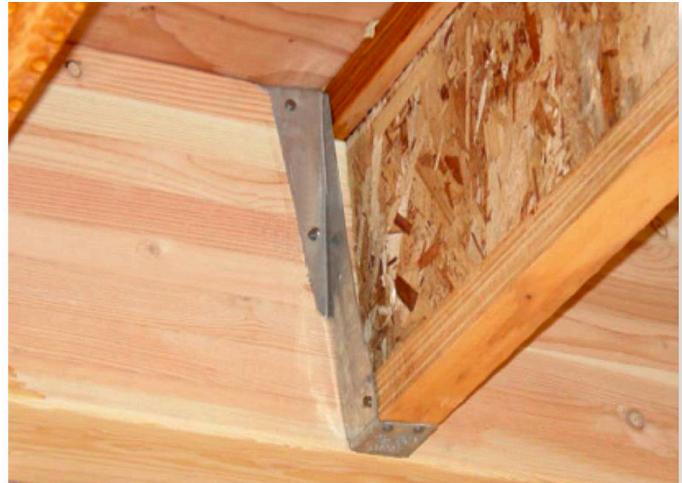
### 1. Improper Nailing of an I-Joist

The side nail into the bottom flange of the I-Joist is installed at the wrong angle. This may cause splitting of the bottom chord. The nail through the dimple should have been installed at a 30 to 45 degree angle. Nails installed into the underside of the bottom chord are not necessary.

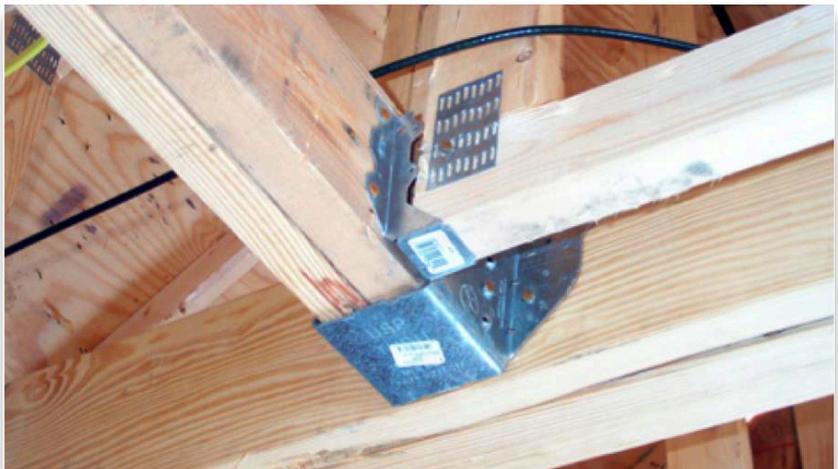
### 2. Improper Bearing

Here the carried truss is not fully bearing on the hanger seat. Some gapping of framing members in a hanger is OK, but gaps greater than 1/8" are unacceptable and compromise the hanger's specified capacity.

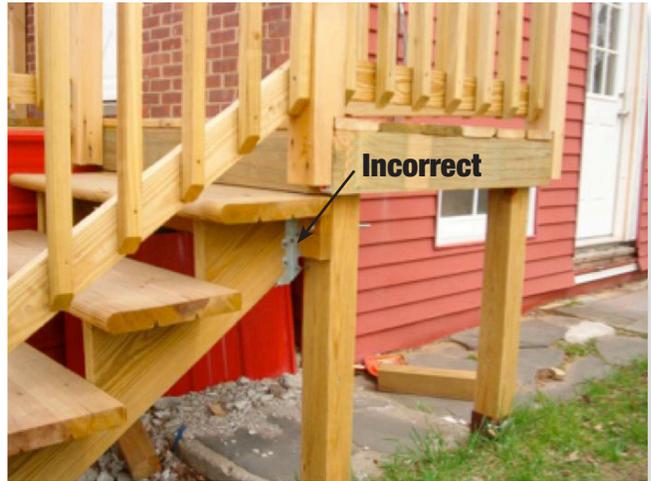
### 3. Improper Hanger

The problem here is the use of a non-sloped hanger. (It is also installed with the wrong type of screws.) In this situation, use a sloped seat hanger, at left. With a standard hanger the wood is bearing only on the very front edge of the hanger. By using a hanger with a sloped seat you get full bearing of the wood in the seat of the connector.

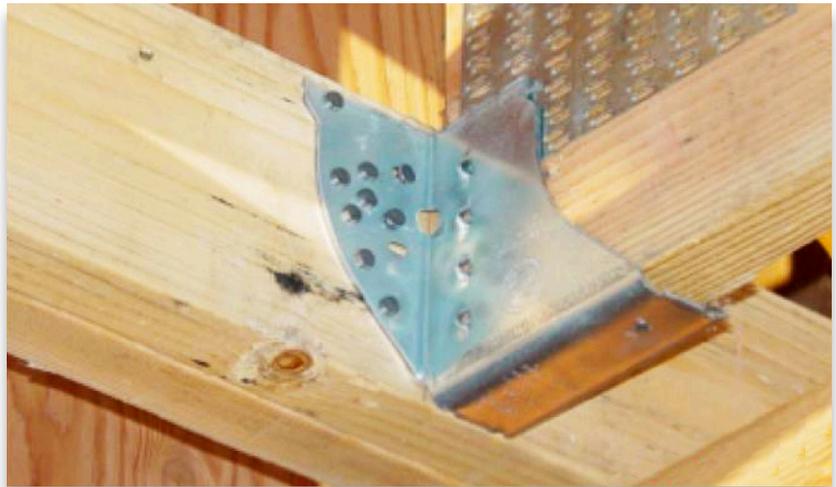
### 4. Shear Nails Missing

The hanger has no double shear nails, so it offers a reduced downward load and no *uplift resistance* at all.

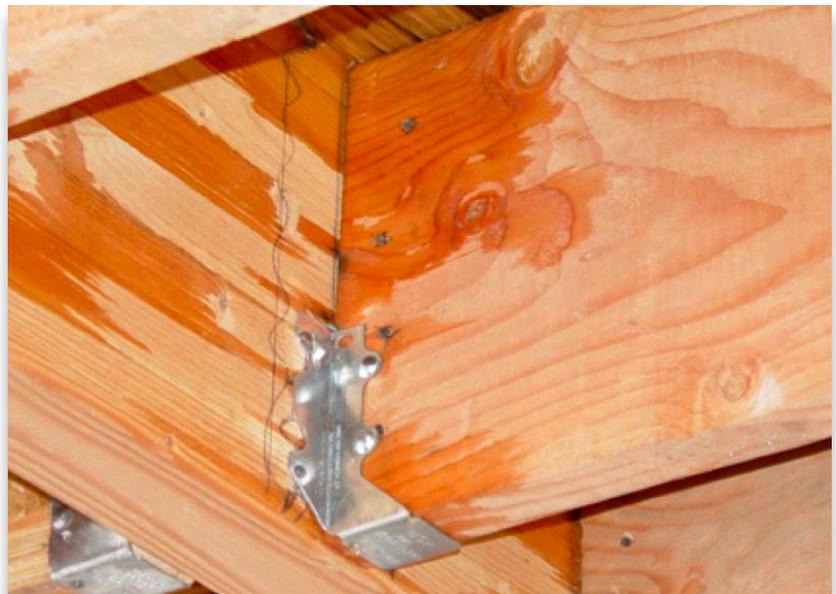
### 5. Undersized Hanger

Hanger height must equal at least 60% of joist height. This is a rule developed to deliver enough hanger capacity and lateral stability of the connection. To fix this without tearing out the existing hangers, *framing angles* could be added above the hanger to add lateral stability.
